PURPOSE

The purpose of the test was to verify the performance rating of the standard Caproco access fitting assembly.

Technical discussion CM002, Caproco (1987) Limited, 4815 Eleniak Road, Edmonton, Alberta, Canada T6B 2N1
 Investigation by Ball Welding & Metallurgical Engineering Limited.

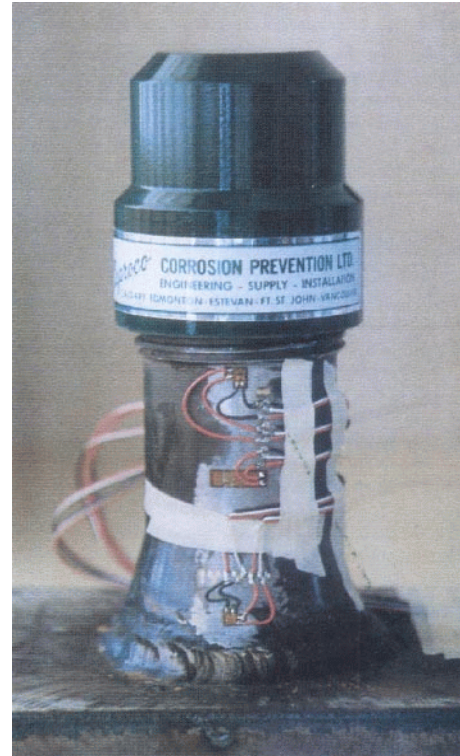
The access fitting was welded to a 25 mm plate of A516 Grade 70 in accordance with Caproco weld procedure CSI, using E7018 electrodes. Micromerement epoxy bonded strain gauges were installed at suspect high stress areas. These gauges were temperature compensated and thermal coefficient of expansion matched for steel.

The gauge locations were:

- Gauge 1 - Hoop stress at bottom thread of external acme threads.
- Gauge 2 - Longitudinal stress at bottom thread of external acme threads.
- Gauge 3 - Hoop stress at mid chamber height
- Gauge 4 - Hoop stress at toe of flareweld.
- Gauge 5 - Longitudinal stress at toe of flareweld.

It can be seen in Table 1 that no longitudinal stresses were present (gauges 2 and 4). The most serious hoop stress occurred at mid chamber height (gauge 3). Even here, the stresses measured were well below the 0.2% offset yield strength for the material.
